INFRASTRUCTURE CATEGORISATION FOR RE-USE OF COAL MINE „LIPNICA“

Muris Nezirović¹, Tihomir Knežiček²

Keywords: categorisation, sustainable development, business incubator, Lipnica mine

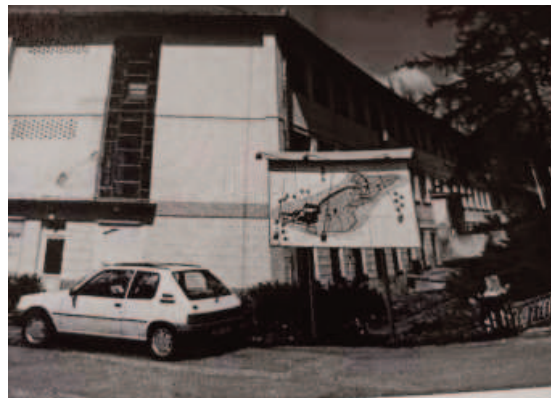
Figure 1. Administration building of the Lipnica mine - today the administration of the incubation centre

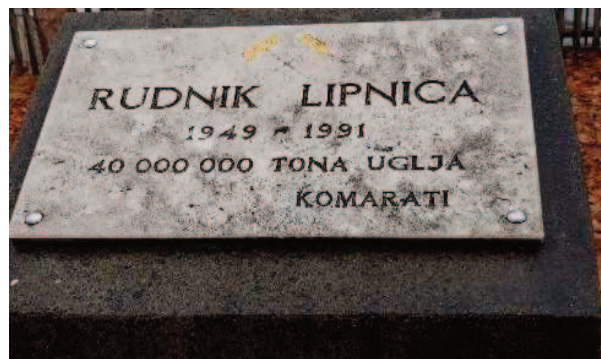
Figure 2. Mine „Lipnica“ 1949. - 1991. Year, produced 40.000.000 tons of coal
